BAILEY SITE REPORT

18 November 2010

To: Mary Koks, Satya Sinha
From: Julie Larson
Subject: Bailey Site Conditions – 30 September 2010

This report summarizes our visual observations of conditions associated with the Bailey Superfund Site made 30 September 2010.

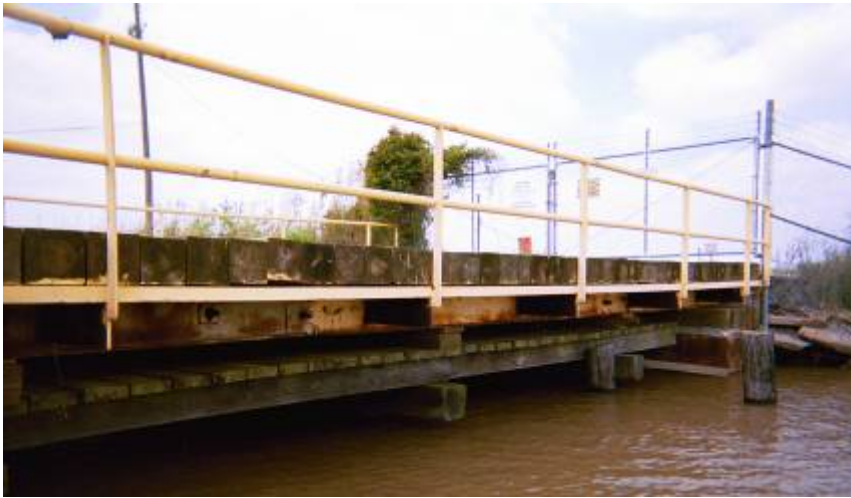
Bridge Supports (2002) – view looking southwest

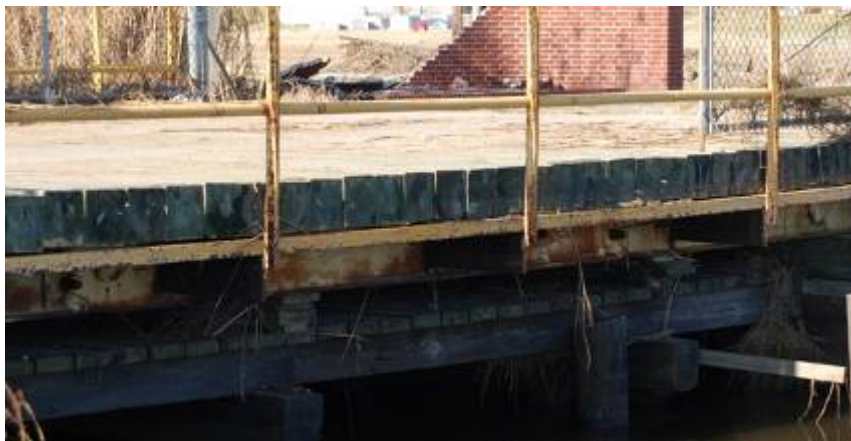
Bridge Supports (2008 Post Hurricane Ike) – view looking southwest

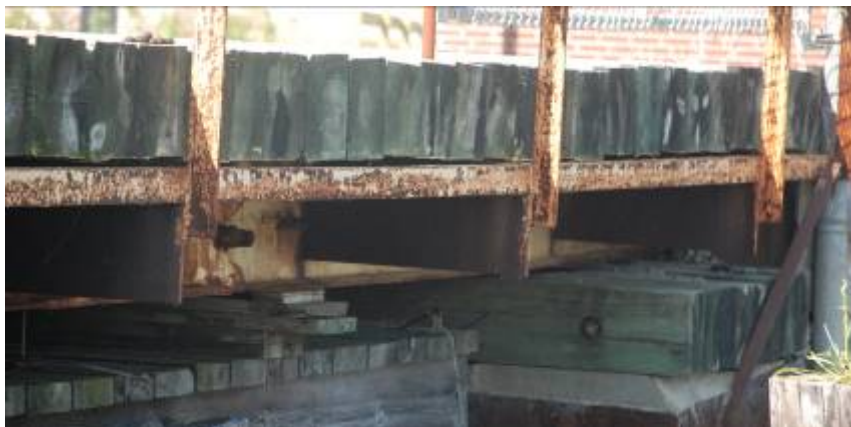
Bridge Supports (2010) – view looking southwest

When observing the bridge handrail system, it was noted that the handrails on both sides of the bridge appear to be intact. The rusting issue appears to be surficial in nature. Parsons recommends confirming this during a bridge inspection. For budgeting purposes, we propose repainting the steel structural members and the handrail. If additional measures result from the bridge inspection, we will develop a cost estimate and obtain authorization prior to implementation.

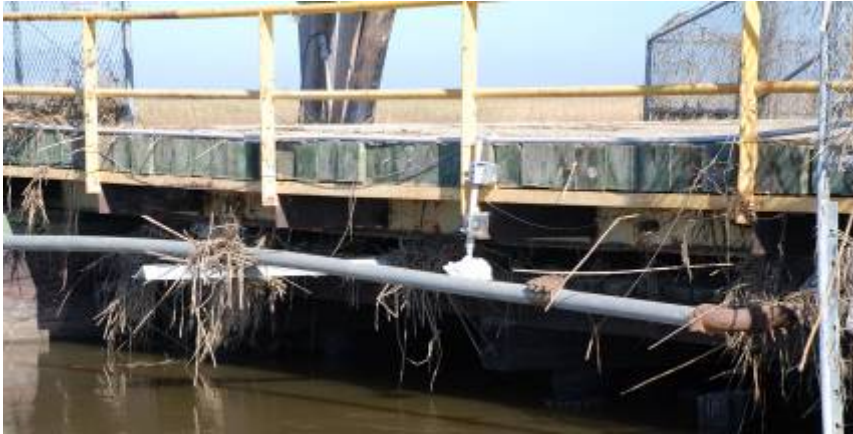
Bridge Supports (2008 Post Hurricane Ike) – view looking northwest

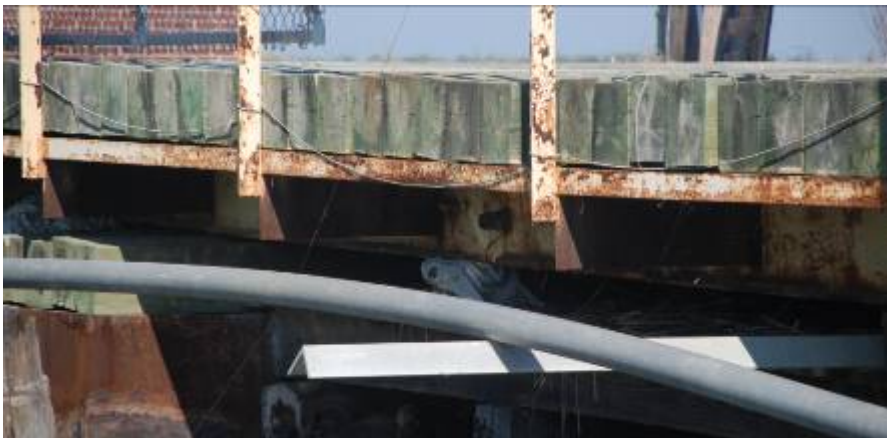
Bridge Supports (2010) – view looking northwest

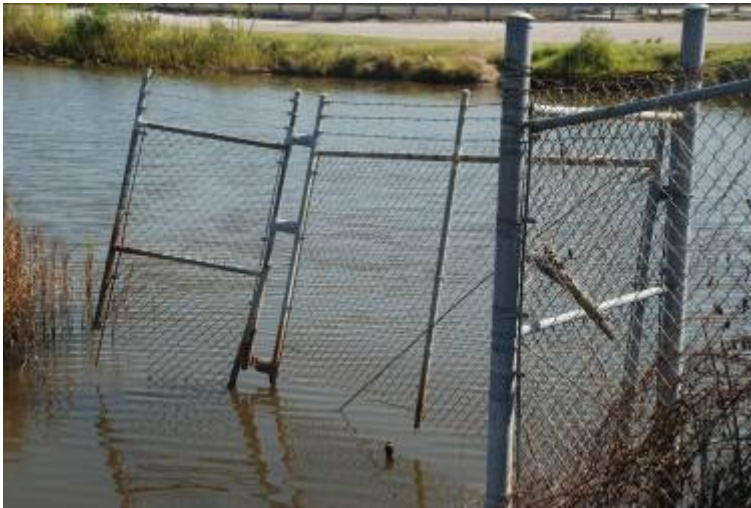
The EPA 5-year report noted that the “fencing located to the north of the main entrance gate has been corroded and the integrity has been compromised.” Parsons has noted this corrosion during previous inspections and confirms that the integrity of that portion of the fence has been compromised. Parsons proposes to replace this portion of the fence during the end of budget year 2010 or first quarter 2011, as a function of weather and subcontractor availability.

Fence panel over water channel at access bridge.

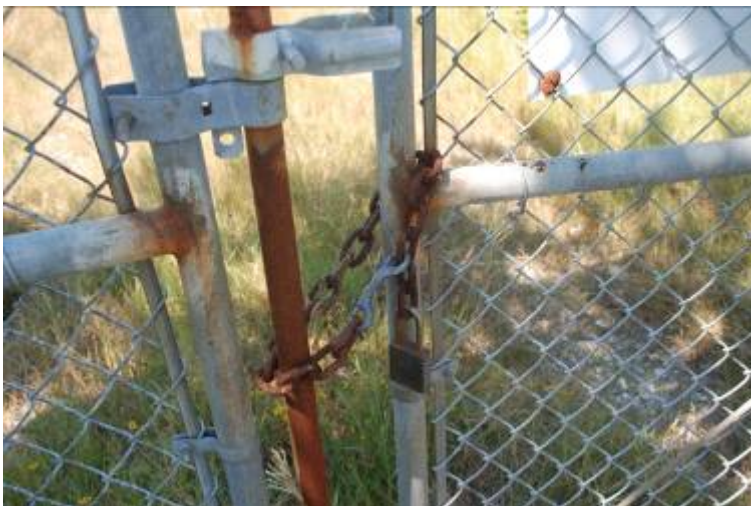
It should also be noted that the gate access along the back side of the property (on the East Dike Cap) is not secured. Parsons observed a chain and lock present for the gate; however, the gate is currently secured with a chain and clasp system (see following photograph). Parsons is of the opinion that this does not provide adequate security for that back gate. If BSSC agrees, Parsons recommends that BSSC contact the property owner to discuss gate security needs and appropriate measures required. A replacement chain and lock can be installed upon approval. Parsons can facilitate the discussion with the property owner, as needed.

East Dike Cap back gate locking mechanism.

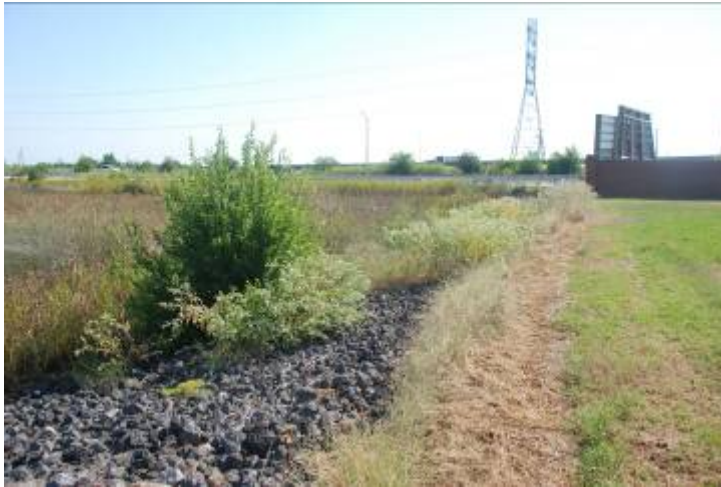
- Animal Burrows – Abandoned animal burrows were noted along the North Dike Cap. Parsons will have the subcontractor fill in the animal burrows during the next mow/weed event.
- Riprap – There are a couple of issues regarding the North Dike Cap riprap. One is vegetation growth in the riprap (see below example photo). This issue will be addressed during the planned upcoming site mowing event.

Vegetation growth in riprap along North Dike Cap – view looking east toward Highway 87.

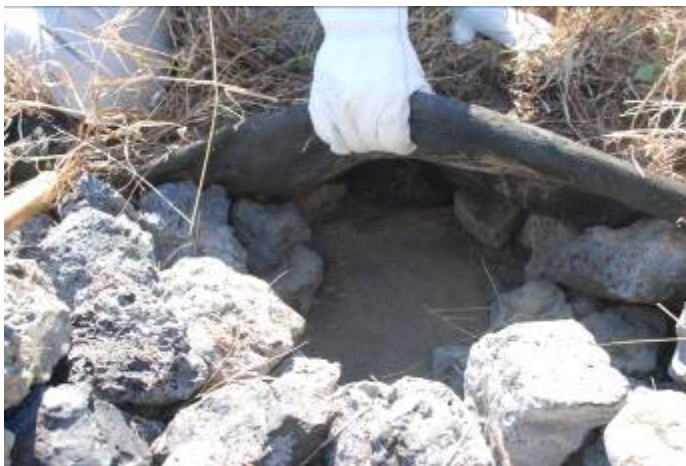
The second issue is exposed geotextile material along the northwest corner of the North Dike Cap. The EPA 5-year review report noted that areas of exposed geotextile fabric, should be “inspected for integrity.” While on site, Parsons inspected the exposed material and confirmed that it is part of the riprap slope armament protection system. It is not connected to the cap liner in any way and therefore poses no immediate threat to the integrity of the cap containment system (see photos).

Slag shifted by hand to determine geotextile material placement.

Parsons interprets that the condition resulting in the geotextile material being exposed relates to down slope shifting of slag materials that has occurred slowly over the past 13 years. Parsons recommends that slag material be added along areas of the North Dike Cap where riprap base geotextile is exposed.

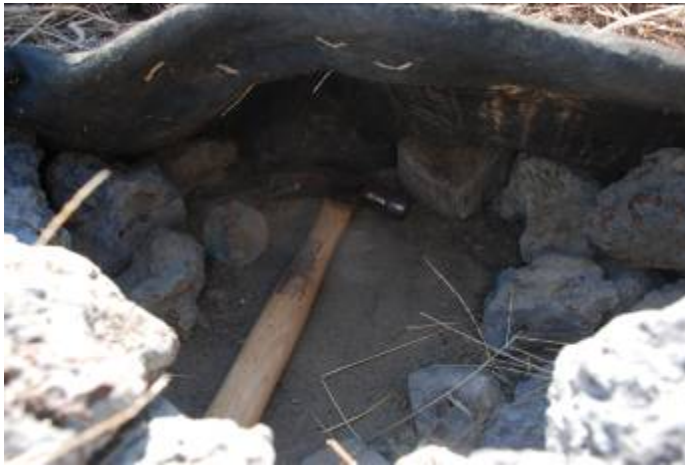
Geotextile material placed under riprap and additional material curls back over riprap.

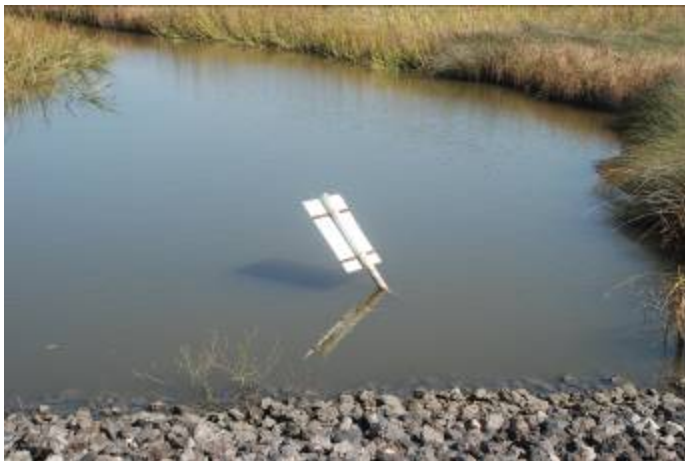
- Signs – There are a number of signs along the North Dike Cap perimeter that Parsons recommends to be repaired, replaced, or re-aligned. The main condition responsible for degradation of sign integrity appears to be corrosion of the sign posts at the water level. Parsons is in the process of identifying recommended means and method to repair/replace the signs to minimize potential future impact to sign integrity due to corrosion. Upon BSSC approval of our recommended method, Parsons will proceed with the sign repair/replacement activity.

Sign along in water channel along north side of North Dike Cap.

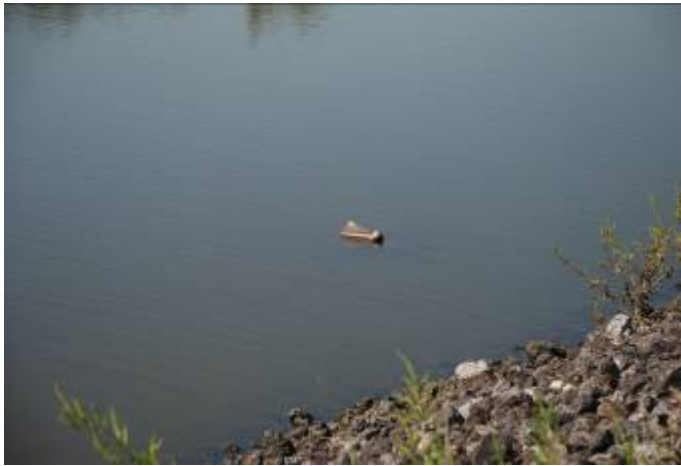
Sign in water channel on south side of North Dike Cap.

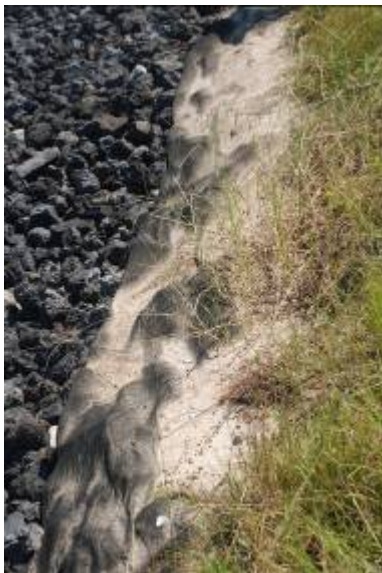
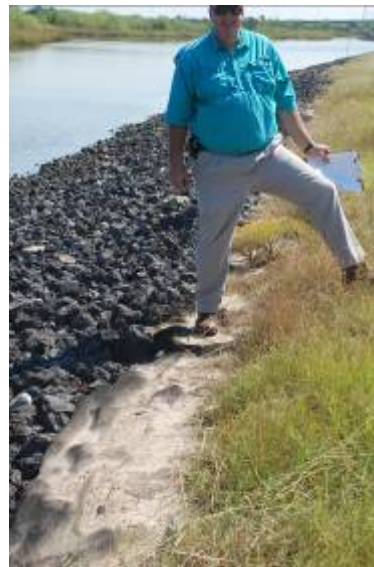
North Dike Cap – Erosion along riprap on northwest side of cap

- Erosion – There is one area where the erosion is noted (per photos). Parsons recommends that this area of erosion be controlled by use of additional seeding for regrowth in addition to hay bales to reduce the amount of erosion while the vegetation takes root. This method has been successfully used before at the Bailey Site.

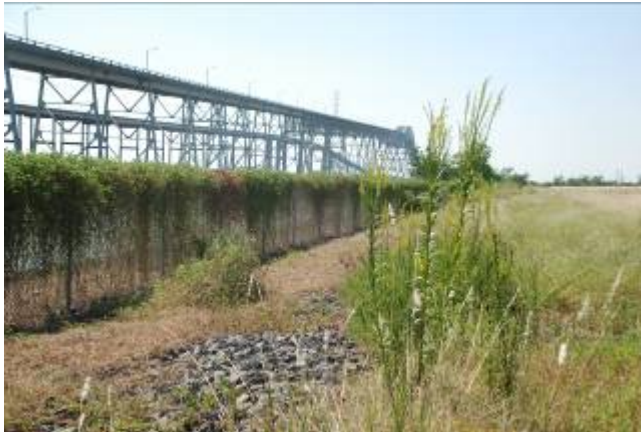
- Animal Burrows - Abandoned animal burrows were noted along the East Dike Cap. Parsons will have the animal burrows filled during a mow/weed event.
- Riprap – There is vegetative growth in the riprap along the East Dike Cap. This issue will be addressed during the upcoming planned site mow/weed event.

Vegetation growth in riprap along East Dike Cap – view looking south toward Port Arthur.
